## **Appendix A: Topographic Data of Upper Quinault River**

This appendix describes new LiDAR and channel survey topographic data collected in 2002 for this study. Also discussed are a topographic survey from 1929 and the comparison of this data to 2002 river elevations.

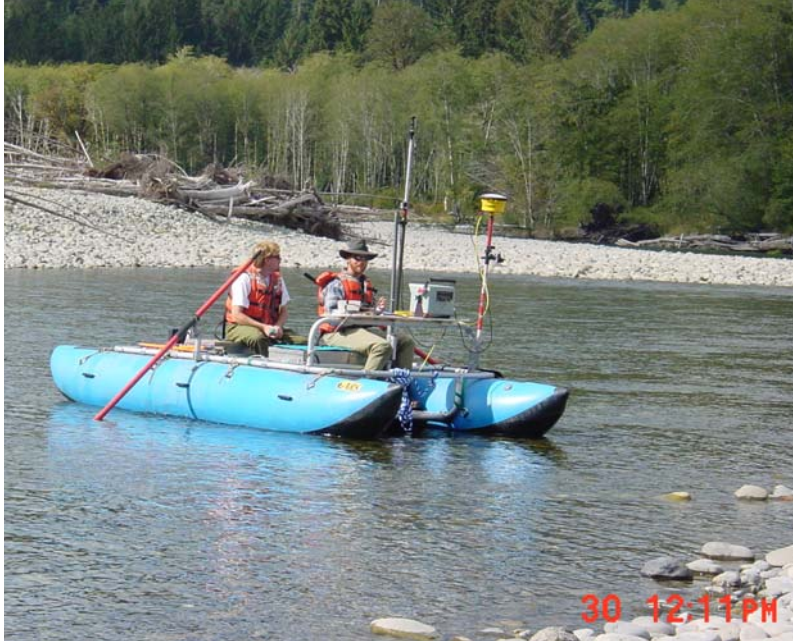
**Figure 1. Bill Armstrong and Tim Randle on survey raft equipped with depth sounder and GPS survey equipment. Photograph taken September 30, 2002.**

A river channel survey was accomplished by Bureau of Reclamation with a boat equipped with a depth sounder, GPS equipment and total station tracking equipment from September 28, 2002 to October 2, 2002 (Figure 1). In some sections of shallow flow where the boat could not be floated, channel bottom was measured by walking rather than using depth sounding equipment on the boat. The goal of the survey was to map the topography of the low flow wetted channel which can not be acquired by commercially available LiDAR techniques. By combining the underwater data with the LiDAR data, a continuous topographic map of the river and floodplain can be generated. A survey of the upstream portion of Lake Quinault delta was also accomplished on October 3, 2002. The data from the river channel and upstream portion of the reservoir survey is available in ASCII format geo-referenced to the same datum as the LiDAR data. The average discharge at the outlet of Lake Quinault during the survey was 407 ft<sup>3</sup>/s (Table 1).

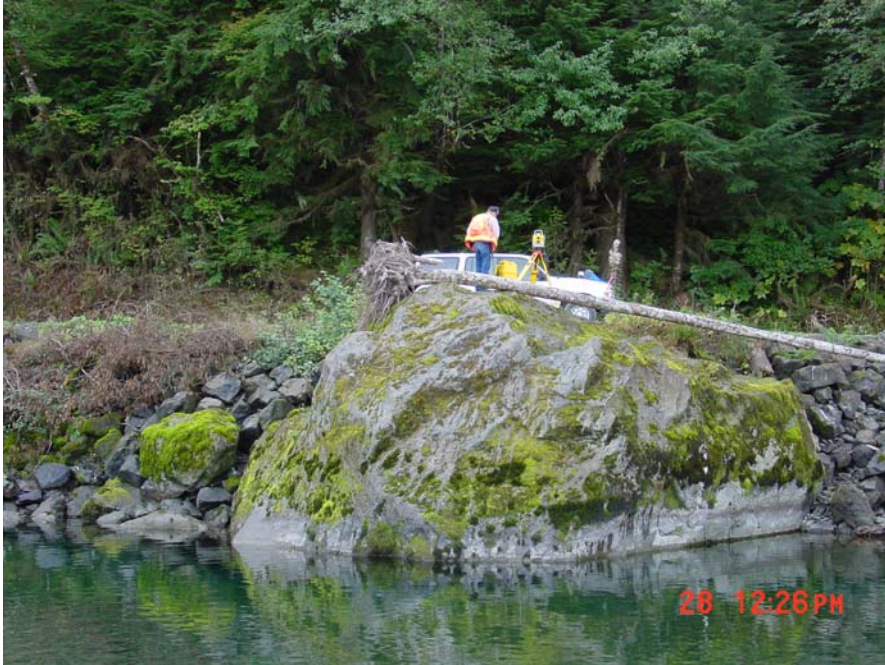
**Figure 2. Example of deep pool near bedrock outcrop along South Shore Road. Note the riprap placed to protect South Shore Road on either side of the bedrock. Photograph taken September 28, 2002.**

The largest rapid (or drop) in water surface elevation measured in October 2002 was 2.8 meters in height between river kilometer 15.1 to 15.4. The deepest pool measured was 5 meters in depth at river kilometer 17.1. From river kilometer 0 to 7.5, the profile shows a combination of shallow riffle sections with water depths less than 1 meter interspaced with rapid and pool complexes. The rapids measured 0.3 to 0.8 meters of drop and pools at the downstream end of the rapids had 1 to 2.3 meters in depth. From river kilometer 7.5 to 8.3, there is a steeper rapid and pool complex (relative to the downstream reach) with a 0.0068 slope. Between river kilometers 8.3 to 9.0, the river in 2002 had one deep pool and flatter slope of 0.0014 (relative to rest of study reach). The deep pool existed where the river ran east across the valley into a riprapped section of road. This section of river shifted to the south side of the floodplain in a flood following the survey. Between river kilometer 9 to 14.4, a rapid and pool complex is again interspaced with shallow riffles, but the pools are only 1 to 1.5 meters in depth. Between river kilometer 14.4 to 18, a rapid and pool complex were measured with deepest pools existing where the river ran along bedrock outcrops on the south side of the river (along the South Shore Road) (see Figure 2). Additional scour pools existed in the study reach where log jams interacted with the low flow river channel. In some cases the maximum depth of these scour pools could not be measured because the boat had to be portaged around the log jams and the depth was too deep to wade by foot.
